AIR SERVICE INFORMATION CIRCULAR

August 1, 1922

No. 360

REPORT OF STATIC TEST OF THE JUNKER L-6 MONOPLANE

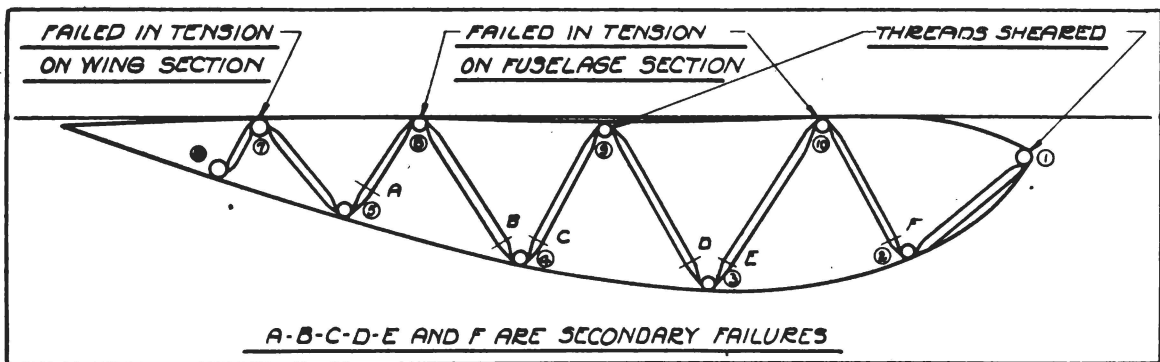
FIG. 10.

The right wing broke off at the junction of the wing and the center section.

On examining the failure it was noted that on spars Nos. 1 and 9 the threads sheared off of the couplings.

On spars Nos. 8 and 10 the failure occurred in the center section where the tubes failed in tension.

Spar No. 7 failed in tension on the wing side of the joint.

Six of the corrugated brace members of the wing spars failed by buckling.

NOTE: Diagram of the spar failures of the right wing at the junction of center section. Sketch shows wing inverted as for test.

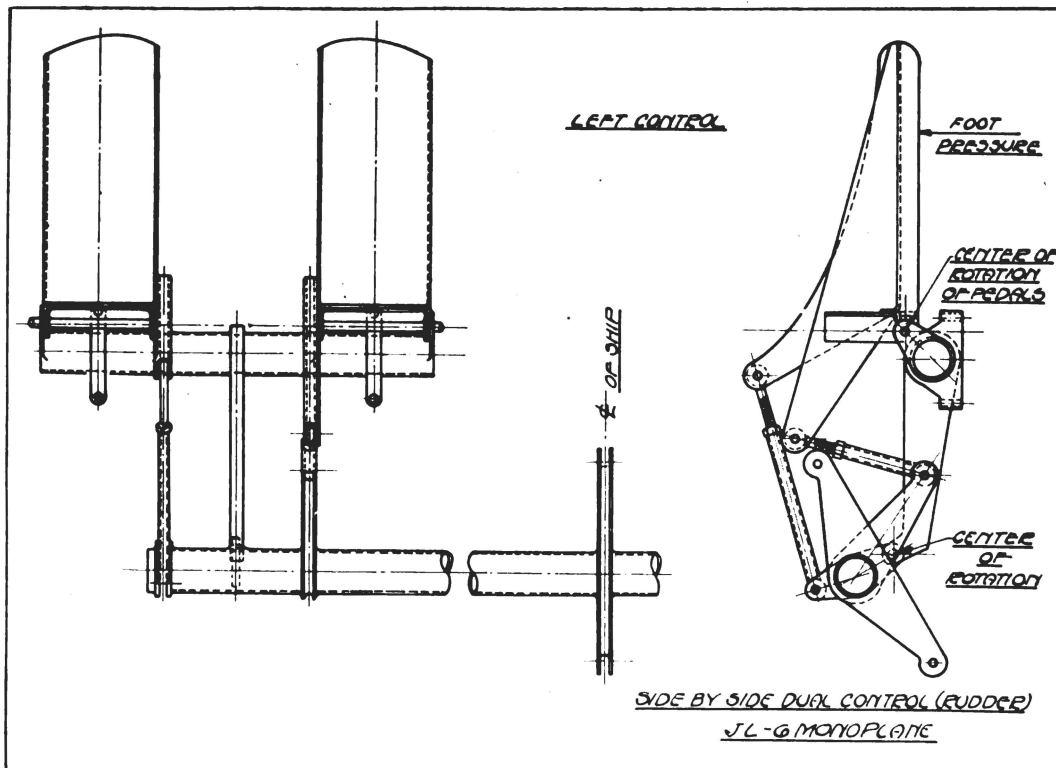
FIG. 33.

The rudder and fin carried the load satisfactorily all through the test, but the left rudder pedal of the right control failed by twisting at an average loading of 27.5 pounds per square foot.

Although the rudder-control system of the JL-6 monoplane is adequate for an airplane of this type, it is recommended that a standard control system be designed for this airplane. This would eliminate lost motion in the joints.

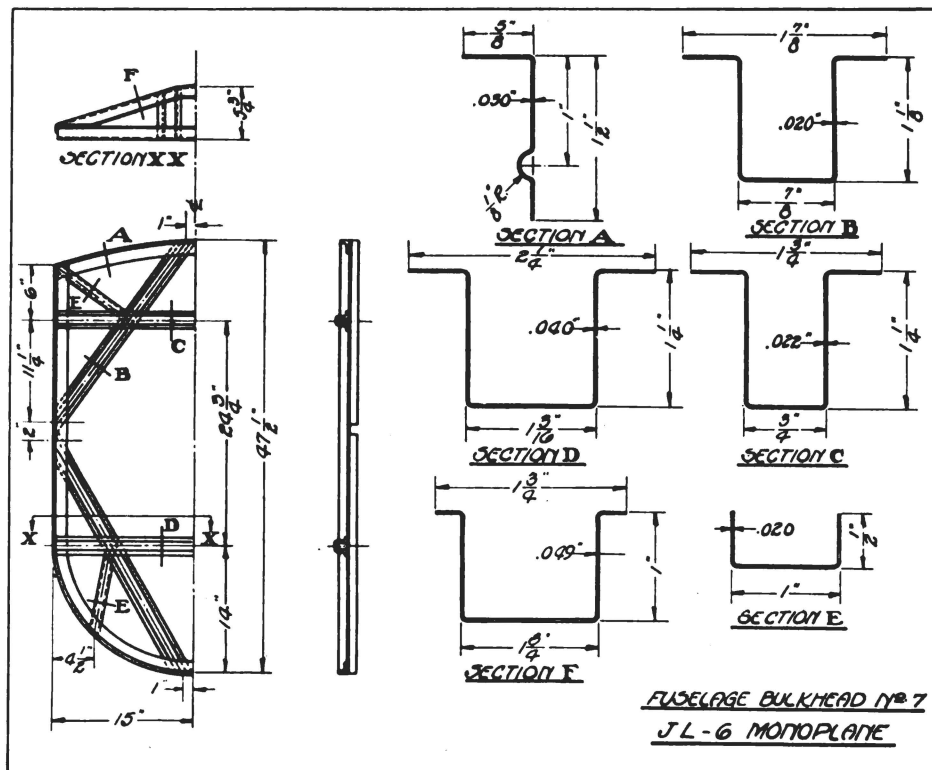
FIG. 45.

At an average loading of 25 pounds per square foot the bulkhead supporting the walking beam between the first and second linkages of the elevator control failed. Both the rivets tore out and the metal tore where the failure occurred.

Figure 65 is a picture of the fuselage. Figure 45 is a drawing of the bulkhead supporting the elevator control walking beam. This bulkhead failed while the elevator was being tested.

A piece of corrugated duralumin riveted in the fuselage between the fuselage cover and the bulkhead mounting the elevator-control walking beam would strengthen the bulkhead sufficiently.

It is recommended that reinforcing strip be riveted in the fuselage around the bulkhead which carries the rear walking beam of the elevator controls. This would eliminate failure similar to the one in the elevator test.

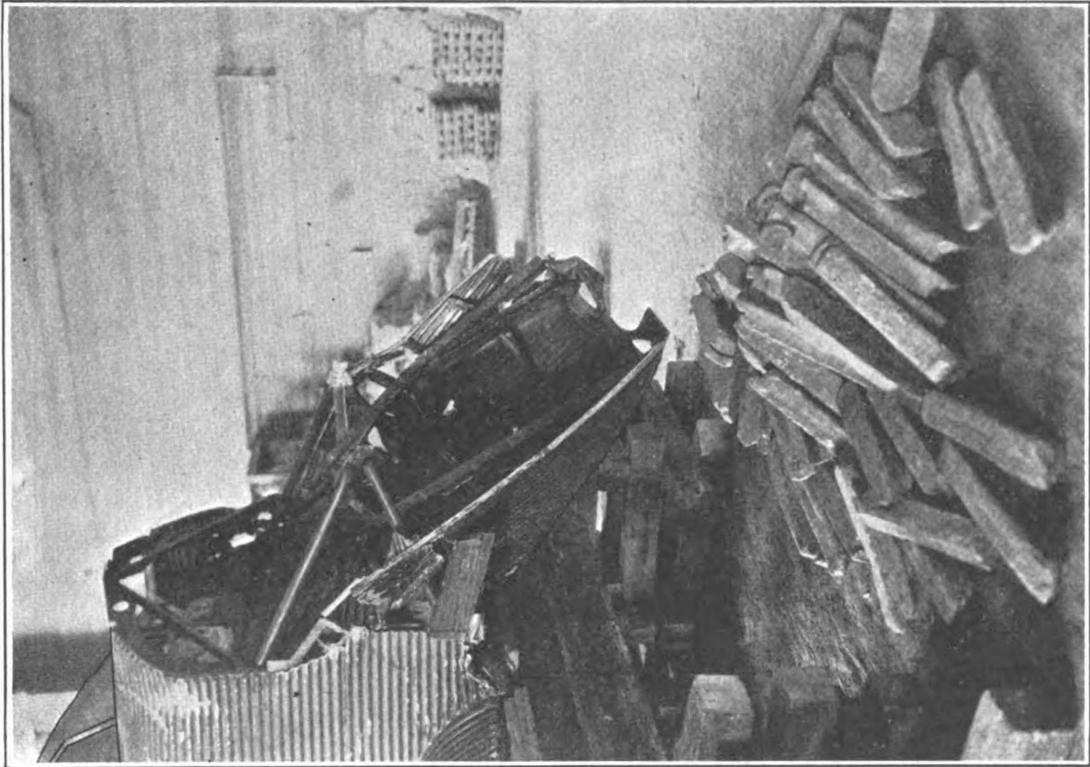
FIG. 50.

Load factor.	Load, in pounds, at—					Total load.	Remarks.
	A	B	C	D	E		
2	1,588	900	460	700	892	4,480	
2.5	1,985	1,125	625	875	1,115	5,725	
3	2,382	1,350	790	1,050	1,338	6,910	
3.5	2,779	1,575	955	1,225	1,561	8,095	
4	3,176	1,800	1,120	1,400	1,784	9,280	
4.5	3,573	2,025	1,285	1,575	2,007	10,465	
5	3,970	2,250	1,450	1,750	2,230	11,650	Fuselage buckled at seams.
5.5	4,367	2,475	1,615	1,925	2,453	12,835	
6	4,764	2,700	1,780	2,100	2,676	14,020	
6.5	5,161	2,925	1,945	2,275	2,899	15,205	
7	5,558	3,150	2,110	2,450	3,122	16,390	Failure; motor support collapsed.

NOTE.—The forward end collapsed before the jacks were free under the load at (E). After the fuselage was counterbalanced the load was imposed at (E). The next failure occurred aft of bulkhead No. 4.

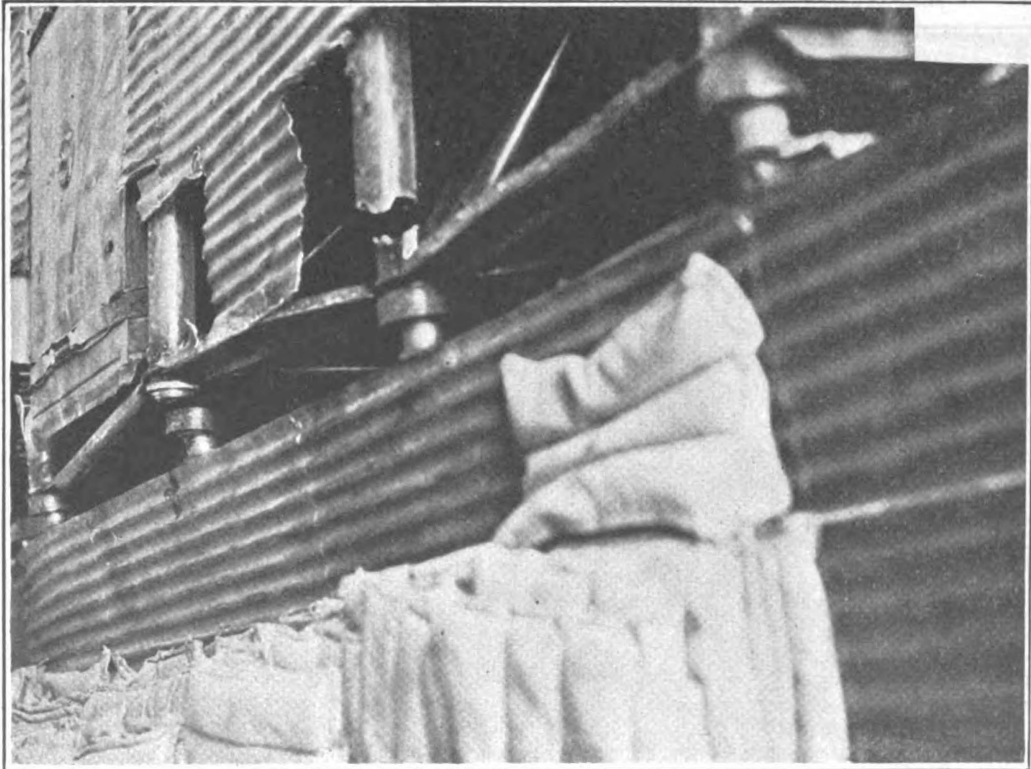
FIG. 60.

Subsequent examination of the failures showed that the shearing strength of the threads on the spar ball joints was equivalent to the tensile strength of the duralumin spar.

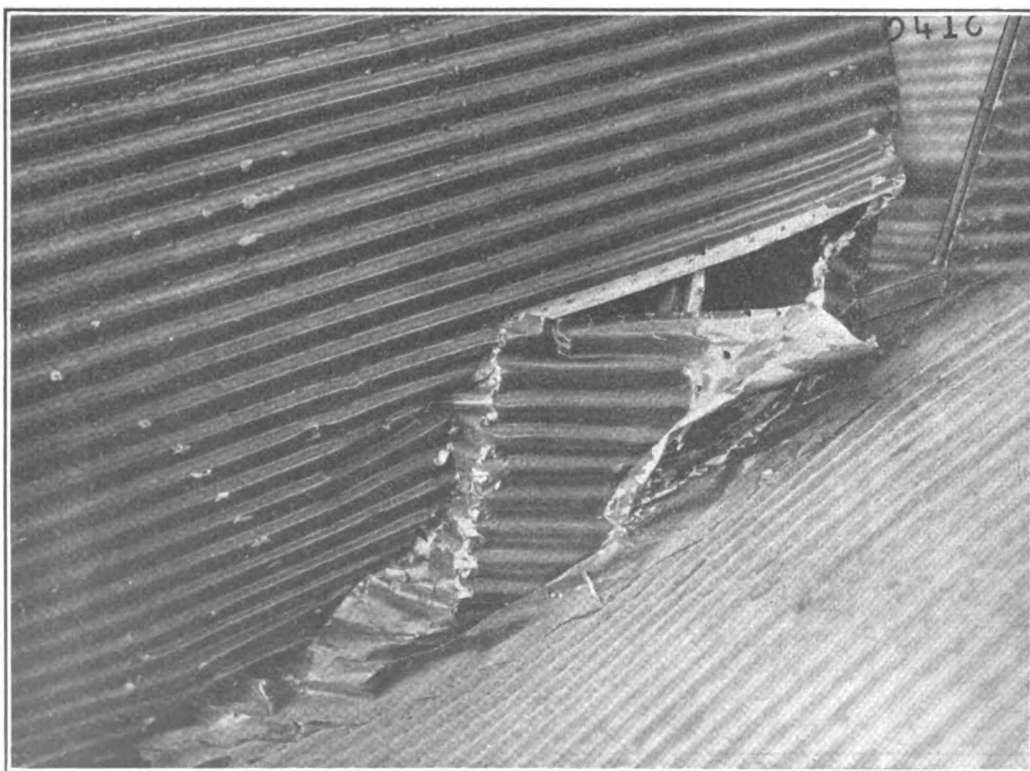
FIG. 62.

The fuselage withstood a load factor of 4.5 without any considerable distortion, but when a load factor of 5 was reached the rear part of the fuselage buckled along the side seams.

lent to the same factor 7) was allowed to settle and the rear portion collapsed. The first failure occurred before the jacks supporting the rear load had been fully released. The second failure occurred just back of the cabin.

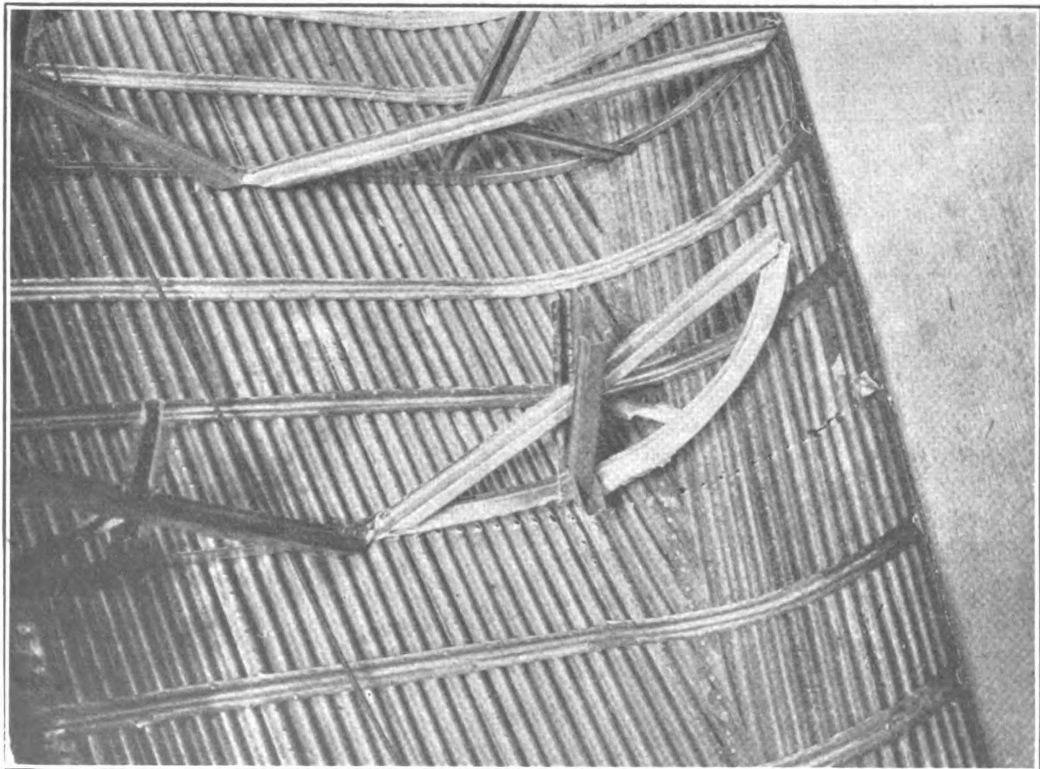
FIG. 64.

The required average load per square foot for the horizontal tail surfaces is 25 pounds for an airplane of this type. Since the surfaces themselves showed no signs of failure during the test, they are structurally satisfactory. However, the controls are weak, since the failure of the control stick occurred at an average loading of 15 pounds per square foot and the failure of the torque tube occurred at an average loading of 20 pounds per square foot. The bulkhead failed at an average loading of 25 pounds per square foot.

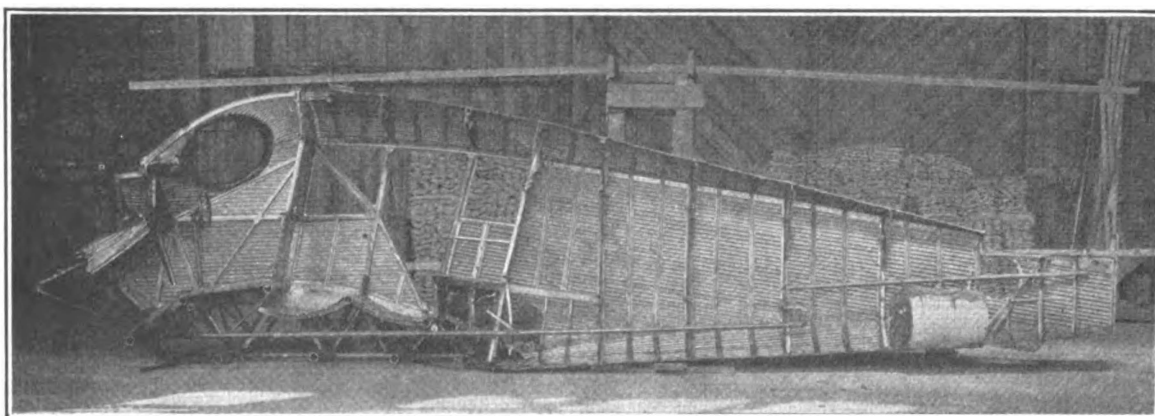
FIG. 65.

Figure 65 is a picture of the fuselage showing the elevator controls. Figure 64 is a picture of the failure of the bulkhead. Figure 34 is a drawing of the aileron and elevator control.
